IN THE  
**Supreme Court of the United States**

No. .... **78-1216**

**APPENDIX TO THE PETITION FOR A WRIT OF  
CERTIORARI TO THE UNITED STATES  
COURT OF APPEALS FOR THE NINTH CIRCUIT**

Appellant BOAC appeals from an order of the United States District Court for the Western District of Washington granting appellee The Boeing Company ("Boeing") summary judgment in a suit arising out of the crash of a Boeing 707 near Mt. Fuji, Japan, on March 5, 1966. BOAC, which owned and operated the plane, had sued Boeing for damages, alleging negligent design and manufacture,

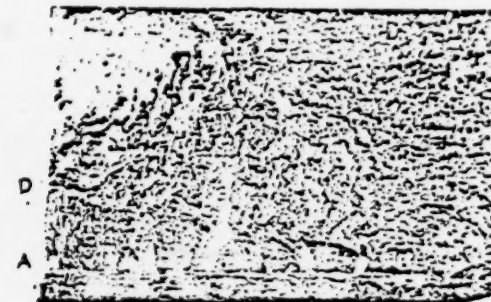
Fig.27&28

The fracture origin on one side of hole R1 is shown in monochrome in Fig. 27, and in colour in Fig. 28. The area indicated ABCD Fig. 27, exhibits features characteristic of fatigue fracture. In the fracture sequence the area of fatigue was followed by an area of plane strain fracture BCDE, and this in turn was followed by plane stress frac-

ture to complete rupture. The area of plane strain fracture can be clearly seen in Fig. 28, and is indicated A. It is apparent from Fig. 28 that corrosion of the fatigue areas of the fracture had occurred. Fig. 29 shows that fatigue cracks started at seven levels, at least, in the bore of hole R1. These are indicated A, B, C, D, E, F and G. Fig. 29 also shows considerable corrosion pitting of the bore of hole R1. Part of another fracture, Fig. 30 was also received. Failure had been initiated by fatigue fracture and multiple fatigue crack initiation was again apparent. The latter feature can be seen in Fig. 31, fatigue
